REPORT DOCUMENTATION PAGE		READ INSTRUCTIONS BEFORE COMPLETING FORM	
1. REPORT NUMBER	2. GOVT ACCESSION NO.	3. RECIPIENT'S CATALOG NUMBER	
	41-7405		
4. TITLE (and Subtitle)		5. TYPE OF REPORT & PERIOD COVERED	
Phase I Inspection Report Mead Reservoir Dam Lake Champlain Basin, Clinton County, N.Y. Inventory No. 237		Phase I Inspection Report National Dam Safety Program

**LAKE CHAMPLAIN BASIN  
MEAD RESERVOIR DAM  
CLINTON COUNTY, NEW YORK  
INVENTORY NO. N.Y. 237  
PHASE I INSPECTION REPORT  
NATIONAL DAM SAFETY PROGRAM**

PHASE I INSPECTION REPORT  
NATIONAL DAM SAFETY PROGRAM  
MEAD RESERVOIR DAM  
I.D. NO. NY-237  
DEC NO. 218B-236  
LAKE CHAMPLAIN BASIN  
CLINTON COUNTY, NEW YORK

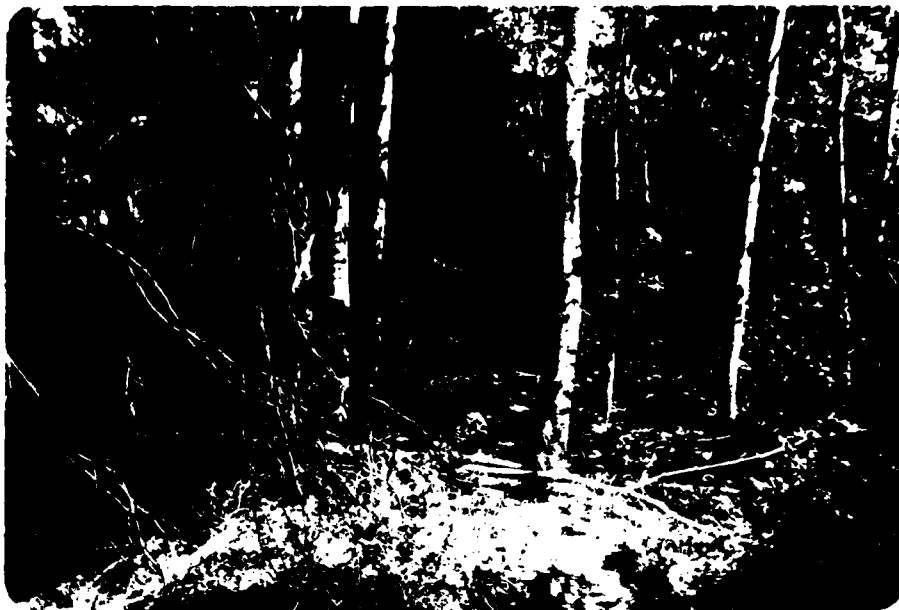
The crest of the embankment was slightly uneven with several minor irregularities noted. At the left end of the dam, the crest of the embankment slopes gradually downward. This segment of the embankment with a lower crest level is called an emergency relief weir on the plans.

CREST OF EMBANKMENT AT LEFT END- LOOKING  
TOWARD SECTION CALLED EMERGENCY BELIEF VEIR

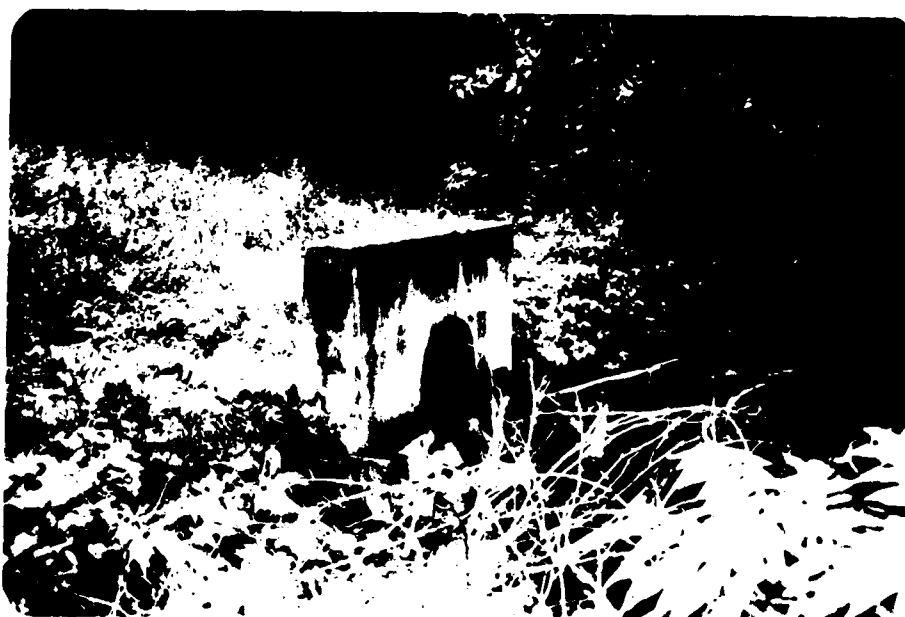
Both the gatehouse and diversion inlet pipe appeared to be in good condition. Some small cracks were noted in the gatehouse concrete walls.

DIVERSION CONDUIT INTO RESERVOIR  
AT RIGHT END OF DAM

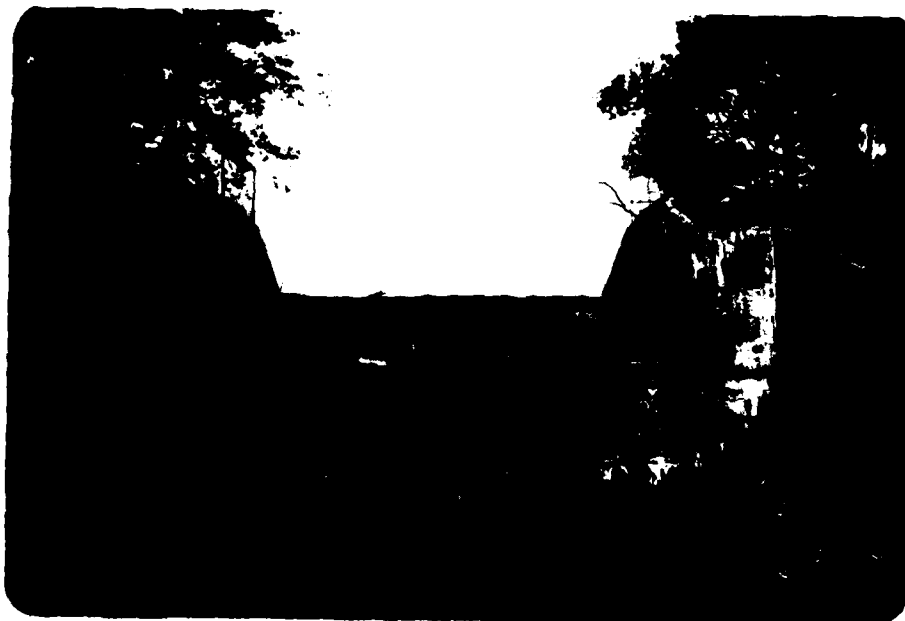
The spillway was in satisfactory condition. There were some small cracks in the abutment walls and some spalling on the downstream face of the gravity section. Minor leakage through the gravity section was also noted. This leakage was exiting about 2 feet below the spillway crest. There was some localized erosion on the upstream embankment slope for about 20 feet from the spillway's right abutment. This erosion was believed to be the result of wave action.

SPILLWAY SECTION  
NOTE LEAKAGE THROUGH DAM NEAR CREST

1. All trees and brush growing on the dam should be cut to permit a more detailed visual inspection of the embankment.
2. The minor leakage through the upper portion of the spillway gravity section should be eliminated.
3. Grass and weeds growing through the joints between concrete slabs on the spillway discharge exit channel should be removed.
4. The joints between the slabs on the exit channel should be sealed to stop the flow of water beneath the slabs.
5. Debris and sediment in the lower plunge pool should be removed and brush and trees growing immediately downstream of the end of the plunge pool should be cut.
6. An emergency action plan for the notification and evacuation of downstream resident should be developed.

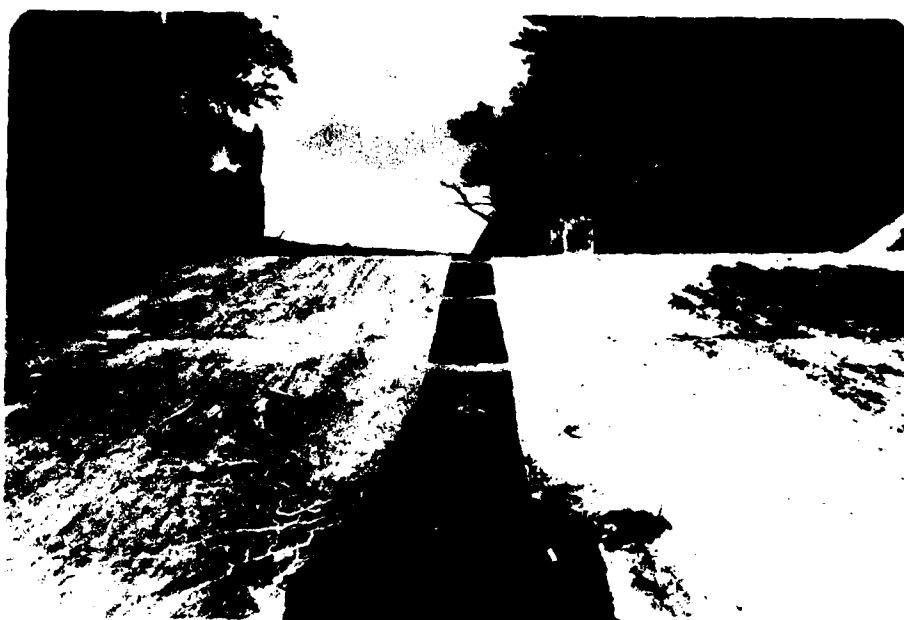
A small amount of water was flowing out of the concrete channel which drains the upper plunge pool. This water flowed over the concrete slabs which line the exit channel and then disappeared beneath the slabs. The water then reappeared approximately 50 feet downstream and flowed over the remainder of the slabs. There was grass and weeds growing through the joints between several of the slabs at the lower end of the channel. Some minor cracking was noted on the channel walls. The lower plunge pool was partially filled with sediment and debris. Brush and weeds were growing in this plunge pool as well. There was some debris around the inlet to the lower plunge pool drain conduit. A spring was observed bubbling up through the bottom of the lower plunge pool. This spring was probably related to the underdrain pipes beneath the spillway channel.

DRAINAGE CHANNEL FROM UPPER  
PLUNGE POOL TO EXIT CHANNEL

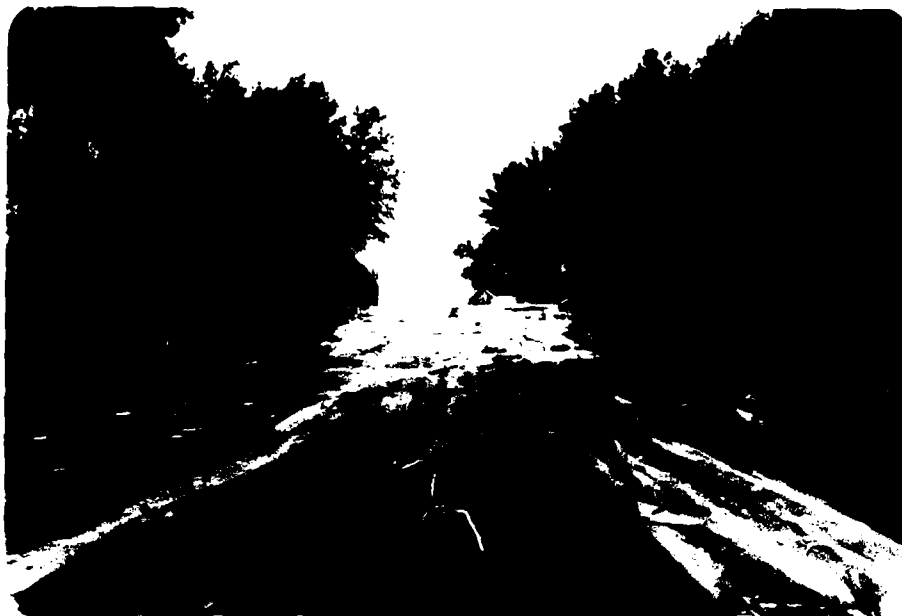
SPILLWAY EXIT CHANNEL  
NOTE WATER APPEARING FROM BETWEEN SLABS

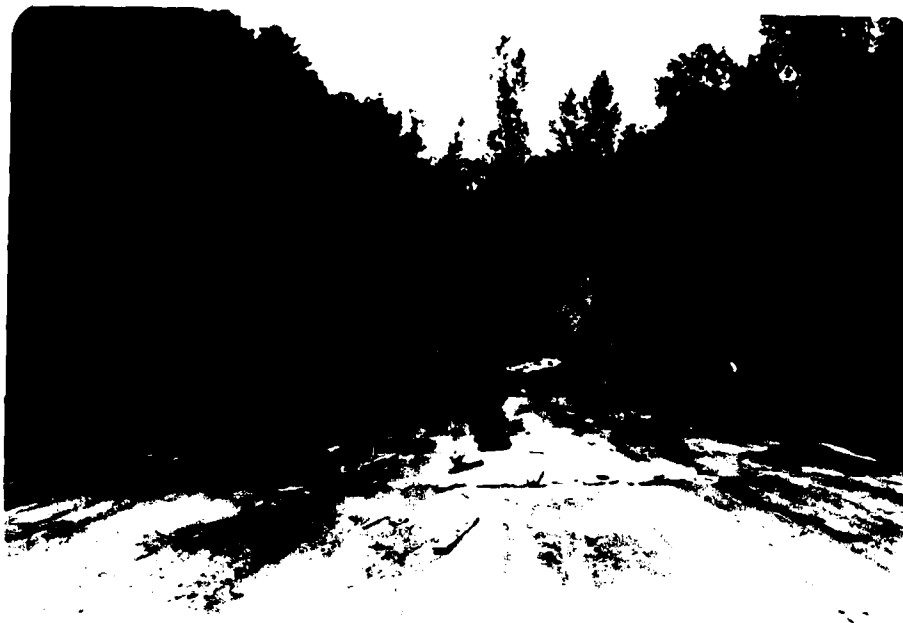
SPILLWAY EXIT CHANNEL LOOKING DOWNSTREAM  
NOTE DEBRIS OR PLUNGE POOL

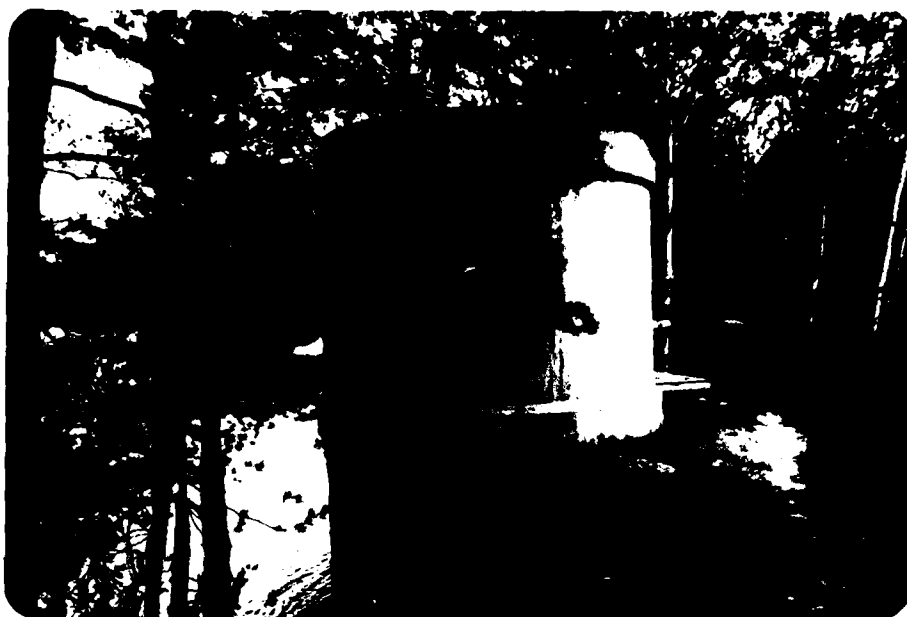
CONCRETE GATEHOUSE ON CREST OF EMBANKMENT
